ÇATALCA CIVIL ARCHITECTURE EXAMPLE RESTORATION AND REFUNCTIONING PROPOSAL

Asst. Prof. Dr. Serdar Kasap

Bilecik Şeyh Edebali University, Faculty of Fine Arts and Design,
Department of Interior Architecture and Environmental Design, Bilecik / Türkiye
ORCID: 0000-0002-7847-3284

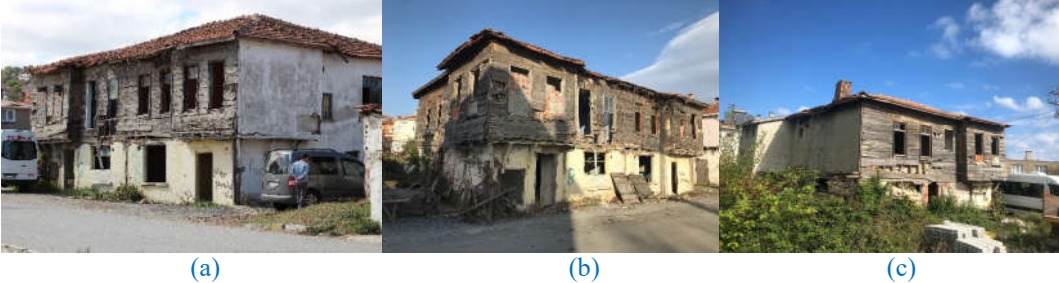
Figure 3. Facade Views of the Building: Northeastern (a), Southeastern (b), and Southwestern (c)

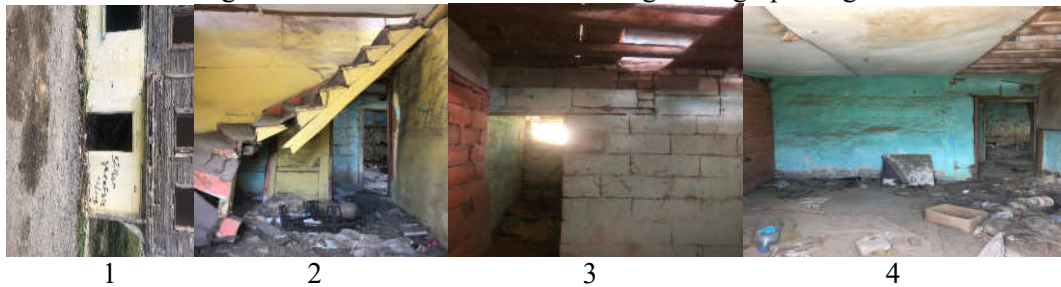
From Z01, access is provided to hall Z02. In this hall, there is a later-added washbasin with a window opening above it. The floor of Z02 is earthen, and the ceiling consists of wooden beams; however, the wooden ceiling is largely deteriorated. On the eastern side of the hall, there is a later-added WC. From the hall, one can pass into rooms Z03 and Z06. The entrance to Z03 is through a doorway with a remaining wooden frame. This room has one wooden window; its floor is earthen, the ceiling has collapsed, and the wooden beams are visible. Inside the room, a later-added bathroom (Z04) is located. Access to Z06 is through a door opening with a remaining wooden frame. On the southeastern façade, there is a bricked-up window opening within the brick wall. The ceiling is partially collapsed and consists of wooden beams and cladding, while the floor is earthen.

Figure 5. Interior Views of the First-Floor Residence Located on the Northern Side of the Building

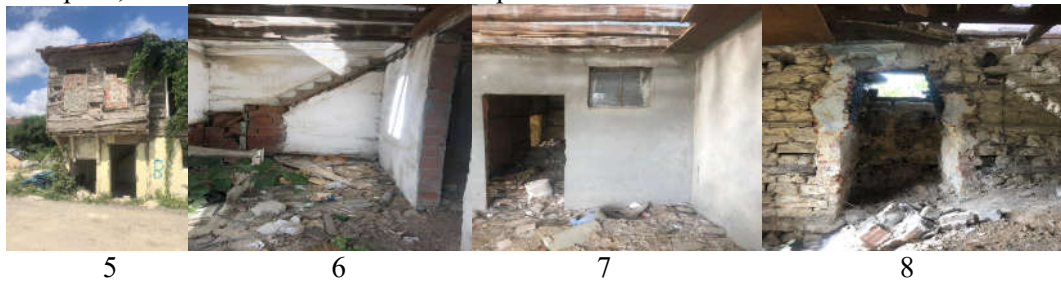
The second dwelling, located on the southern façade of the building, is constructed of brick, timber, concrete block, and original masonry walls. Entry is through a missing door opening. The first room (Z07) is accessed directly upon entry. Access to the upper floor was once provided by a wooden staircase that no longer exists; currently, access is possible only via temporary ladders. The floor is earthen, and the ceiling, partially collapsed, consists of wooden beams and planks.

Figure 6. Interior Views of the Second-Floor Residence Located on the Southern Facade of the Building

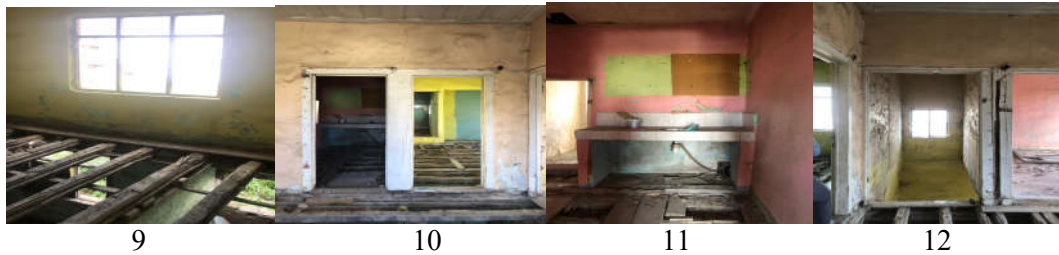
Figure 9. Interior Views of the Second Residence on the South Facade of the Building

Access to the first floor of the second dwelling on the southern façade is possible through room Z07, although the original staircase is missing and replaced by temporary ladders leading to room 108. The eastern wall of room 108 features one original wooden sash window with its frame intact. There is also a door opening that appears to have been added later. The walls of this room are timber-framed. The floor has collapsed, leaving only the wooden beams. The ceiling is the original wooden cladding.

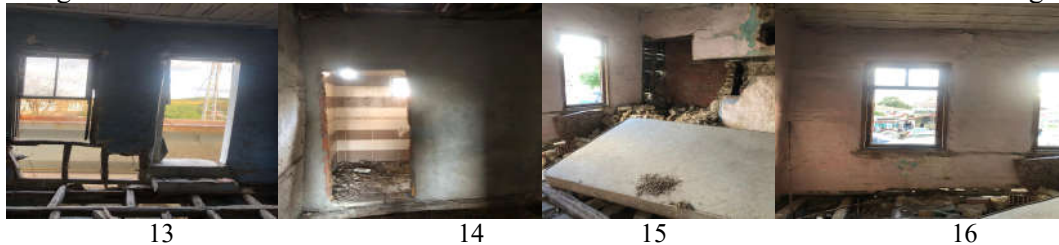
Figure 10. Interior Views of the Second Residence on the South Facade of the Building

Room 107, adjacent to the southern wall of room 108, is accessed through a missing door opening. The floor has collapsed, leaving only the wooden beams, and the ceiling retains its original wooden cladding. Two window openings on the eastern wall have been filled with bricks, and the window opening on the southern wall has been replaced with brickwork.

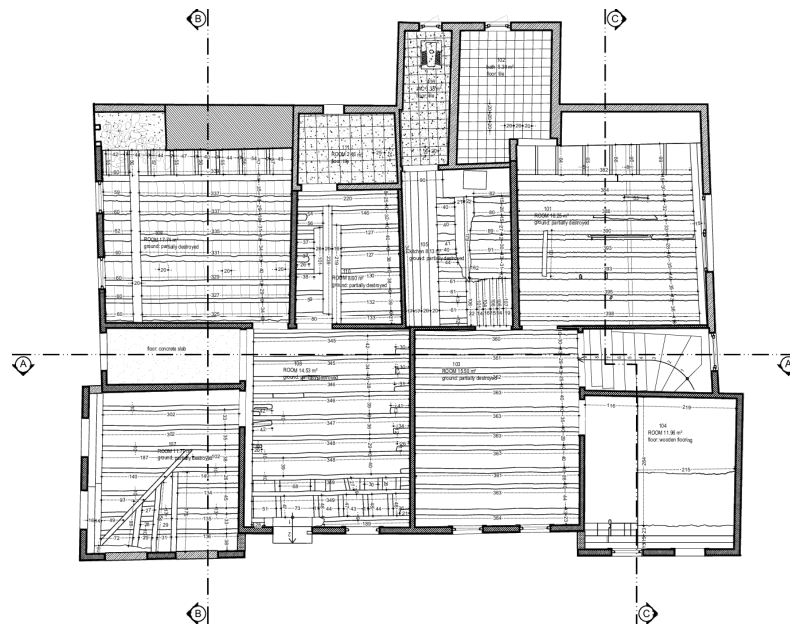
Figure 11. First Floor Survey Drawing

Room 109, adjacent to the western wall of room 108, is accessed through a missing door opening. The floor has collapsed, leaving only the wooden beams. The original wooden ceiling remains, but there are visible collapses. The western wall is partially destroyed, revealing a chimney opening. On the southern wall, there are two wooden windows.

From room 108, access is provided to room 110 through a missing doorway. Room 110 includes a later-added bathroom (room 111) with tiled floors and a missing ceiling that exposes the roof structure. On the western wall, there is one wooden window. The floor is partially decayed, leaving only wooden beams visible. The ceiling is missing, exposing the roof truss system.

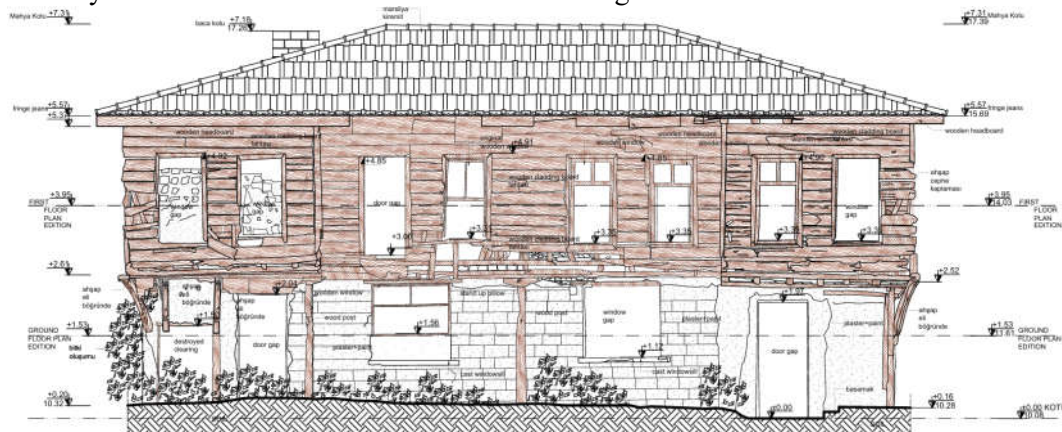
Figure 12. Eastern Facade Survey Drawing

On the eastern façade, there is one wooden window and one window opening on the ground floor. In addition, there are several bricked-up door openings on this façade. Wooden brackets (eli böğründe) are located beneath the bay window projections. On the upper floor, there are four wooden windows, three window openings, and one door opening. The ground floor walls are constructed of brick masonry, while the first-floor walls consist of a timber-frame system with wooden cladding. The eaves of the roof are not very wide and are covered with wooden cladding.

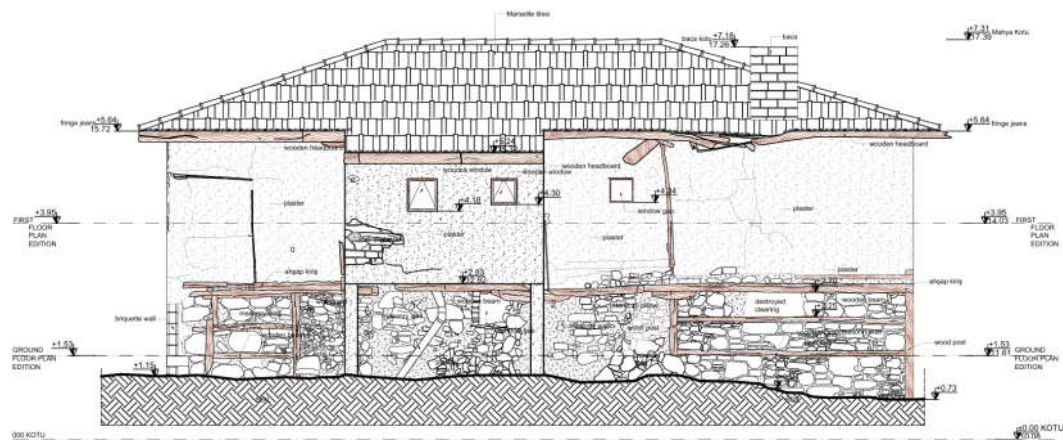
Figure 13. Western Facade Survey Drawing

The western façade of the ground floor retains its original masonry walls, though partial collapses are observed. On the first floor, there is a later-added cantilevered projection supported by two concrete columns. The projection is of reinforced concrete with plastered surfaces. This façade contains three windows, two of which belong to the projecting bay.

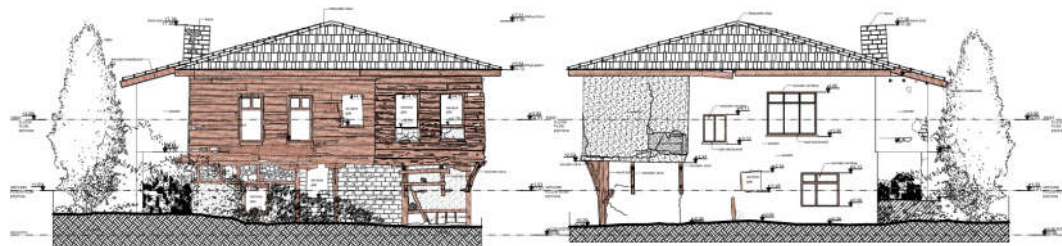
Figure 14. Survey Drawing of the Building: Southern (Left) and Northern (Right) Facade

The southern façade has ground-floor walls made of timber frame and brick masonry, covered with plaster. There are two window openings on the ground floor. The first-floor walls are timber-framed and clad with wooden planks. On the eastern part of this façade, there are two wooden windows and three window openings.

The northern façade walls on the ground floor are of brick masonry. This façade includes one window opening and one wooden window on the ground floor, and two wooden windows on the first floor. The façade surface is plastered.

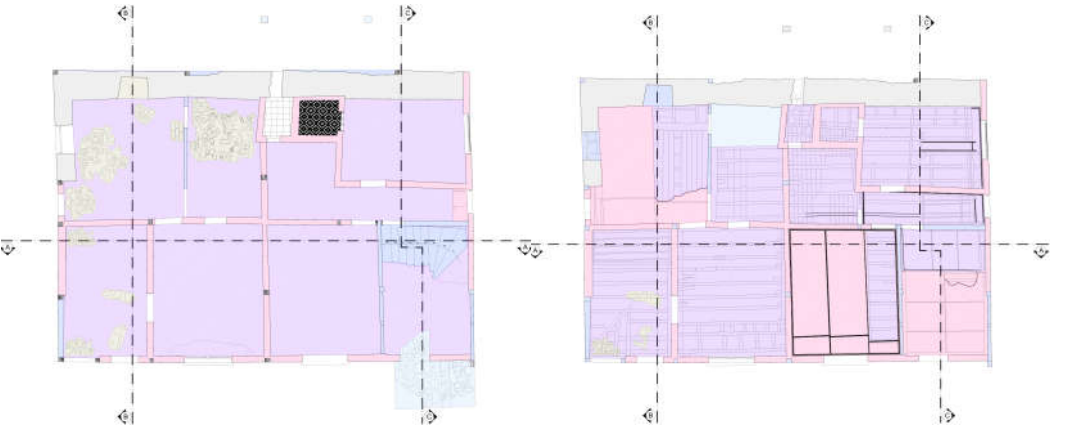
Figure 16. Ground Floor (Left) and Ground Floor Ceiling (Right) Damage Assessment Plan

The original vertical structural system consists of wooden posts; however, deformations and displacements are observed both vertically and horizontally. The spaces between the original posts on the ground floor have been later infilled with brick masonry.

All wooden joinery and façade claddings show severe surface erosion, material loss, and delamination caused by moisture. The deterioration observed in the timber-framed walls

is classified under structural damage. Wooden doors, windows, ceilings, and floors are categorized under wear and surface erosion. Brick and concrete block walls fall under improper repair, while the later-added bathroom and WC units on the first floor are classified as incongruous additions.
