ÇATALCA CIVIL ARCHITECTURE EXAMPLE RESTORATION AND REFUNCTIONING PROPOSAL

Asst. Prof. Dr. Serdar Kasap

Bilecik Şeyh Edebali University, Faculty of Fine Arts and Design,
Department of Interior Architecture and Environmental Design, Bilecik / Türkiye
ORCID: 0000-0002-7847-3284

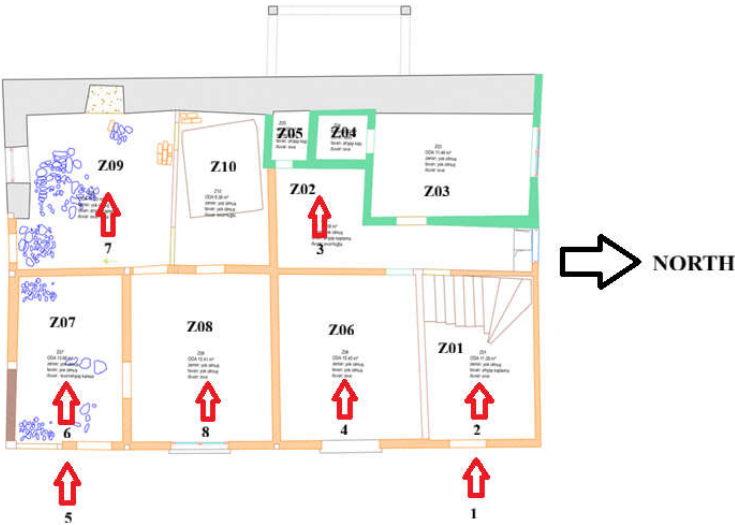
Figure 4. Ground Floor Plan Indicating Photograph Angle

From Z01, access is provided to hall Z02. In this hall, there is a later-added washbasin with a window opening above it. The floor of Z02 is earthen, and the ceiling consists of wooden beams; however, the wooden ceiling is largely deteriorated. On the eastern side of the hall, there is a later-added WC. From the hall, one can pass into rooms Z03 and Z06. The entrance to Z03 is through a doorway with a remaining wooden frame. This room has one wooden window; its floor is earthen, the ceiling has collapsed, and the wooden beams are visible. Inside the room, a later-added bathroom (Z04) is located. Access to Z06 is through a door opening with a remaining wooden frame. On the southeastern façade, there is a bricked-up window opening within the brick wall. The ceiling is partially collapsed and consists of wooden beams and cladding, while the floor is earthen.

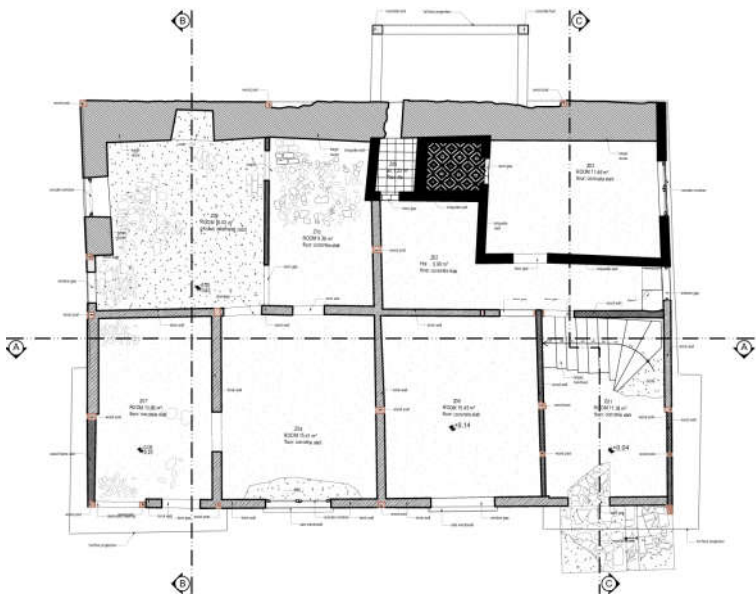
On the right axis of the dwelling, there is a room (Z08) that provides access to two other rooms (Z09, Z10). Entry to Z08 is through a missing door opening. The eastern façade of the room features a wooden window that has been later modified, reducing its original size. The rear room (Z09), adjacent to the left wall, has two window openings on the southern wall. Within the room, there is a fireplace. The floor is earthen, and the ceiling—partially collapsed—consists of wooden beams and cladding. Room Z10, adjacent to the right-hand wall of Z09, is accessed from Z09 and Z08 through missing door openings. The floor is earthen, and the ceiling has collapsed, exposing the timber floor beams of the upper story.

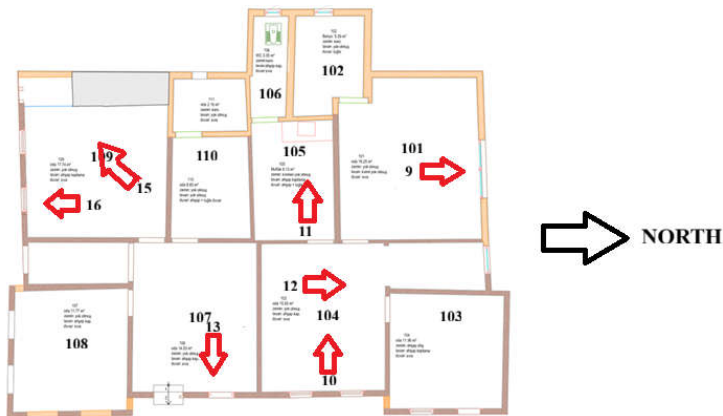
First Floor: Access to the first floor of the first dwelling on the eastern façade is provided via the wooden staircase located in room Z01, leading to room 103. The floor of this room has collapsed, leaving only the wooden beams. The original wooden ceiling remains intact. On the northern façade, there are two window openings. Room 104, adjacent to room 103 on the northern wall, is accessed through a missing doorway. The floor consists of later-added wooden planks, while the ceiling retains its original wooden cladding. On the eastern wall, there is one wooden window and one additional window opening. From room 103, one can access room 101 through a missing door opening. A later-added bathroom is attached to this room, with tiled floors and walls, while the ceiling has collapsed, exposing the roof truss system. The northern wall has one wooden window. The wooden flooring has decayed, leaving the beams exposed. The ceiling is partially missing and includes later modifications. From room 103, there is also access to room 105 through a missing door opening. Room 105 contains a later-added WC (room 106) with tiled flooring and a wooden ceiling. On the southern wall, there is one wooden window. The room, which was used as a kitchen, features a ceramic-tiled countertop. The flooring is partially decayed, and the ceiling consists of later-added wooden cladding.
